2014 Engineer's Annual Report

Vista Community Development District

December 2014

INSPECTOR'S DAILY REPORT

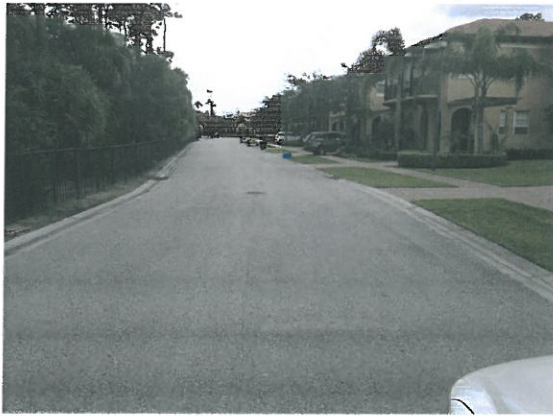
1. Typical Street Inlets and Gutters/Vista #4

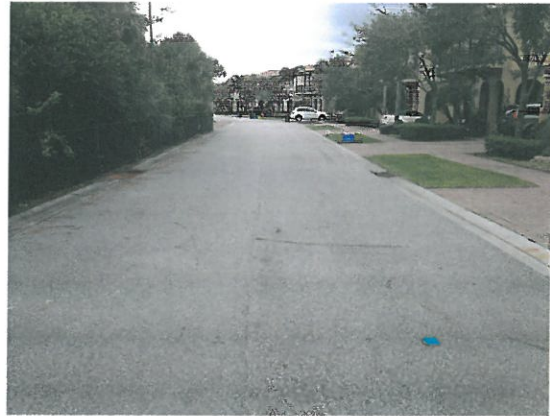
2. Typical Street Inlets and Gutters/Vista # 4

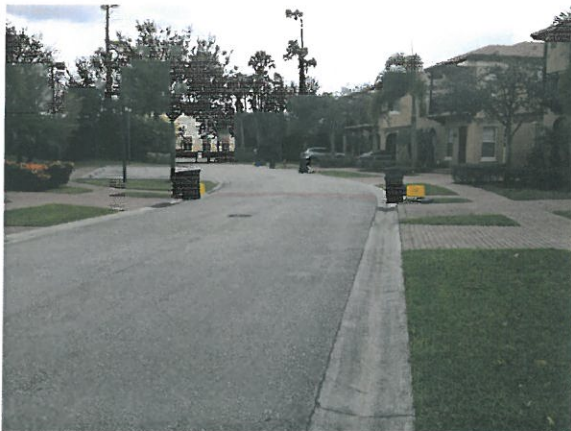
3. Inlets and Gutter Curbs/ Vista #4

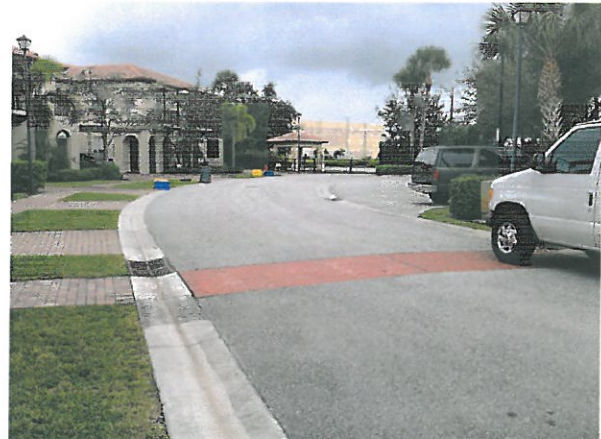
4. Inlets and Gutter Curbs/Vista # 4

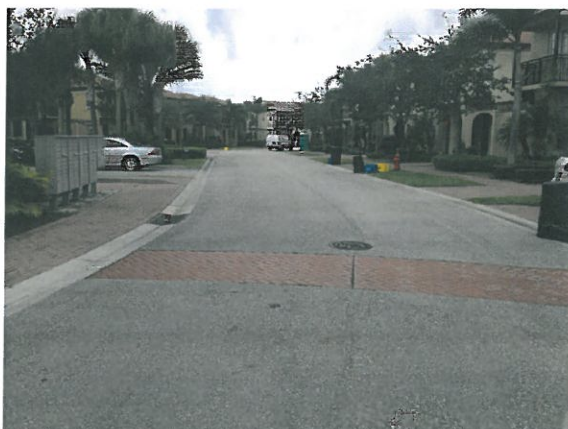
5. Typical Street Inlet and Gutter Curbs

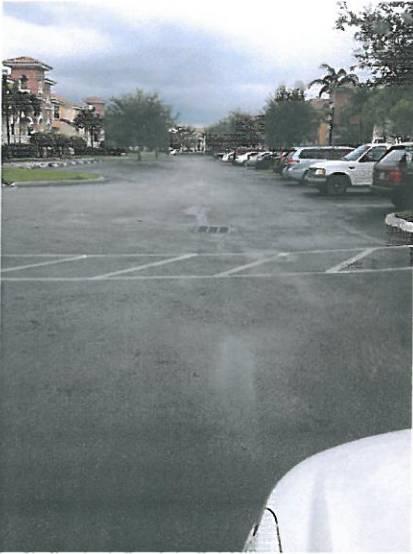
6. Typical Street Inlets/ Vista # 5

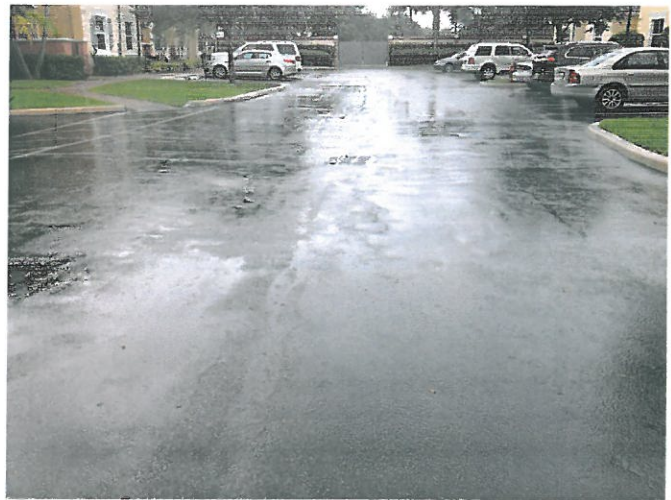
7. Typical Street Inlets/ Vista # 5

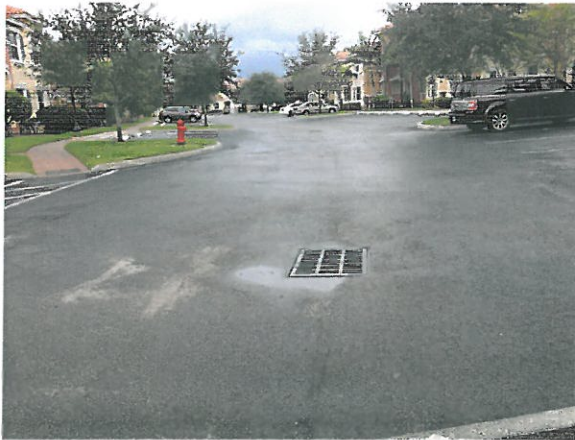
8. Typical Street Inlets/ Vista #5

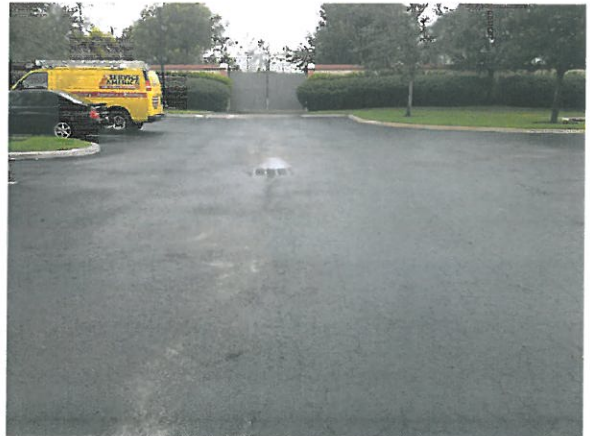
9. Typical Street Inlets/ Vista #5

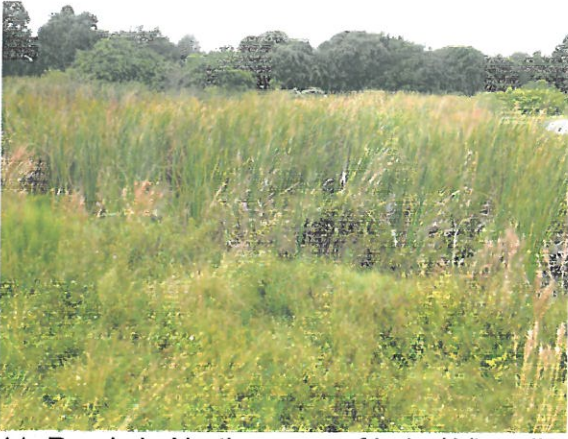
No major erosion of the lake banks was observed during the field review. Aquatic vegetation appears to be growing in the lake. This will require further monitoring to evaluate any potential damage and will require chemically treating and / or clearing prior to acceptance by the District. Final certification of the surface water management system is still required. This cannot be completed until the final site grading (unit construction) has been done. Operation and maintenance of this system is the responsibility of the developer until this system has been completed and accepted by the District.

The ground cover at Vista # 6 has been mowed recently. The lake banks have substantial reed growth. There are more weeds growing along E.O.P. and gutter curbs than last inspection. Deteriorating filter fabric is still in place at most inlets.

11. Reeds in North corner of Lake/ Vista #6

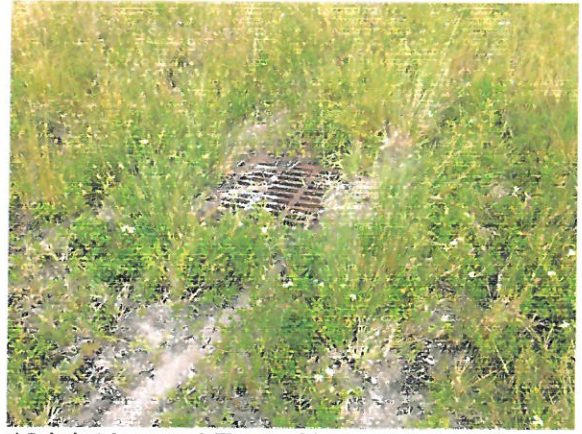
12. Inlet located East of Lake/ Vista # 6

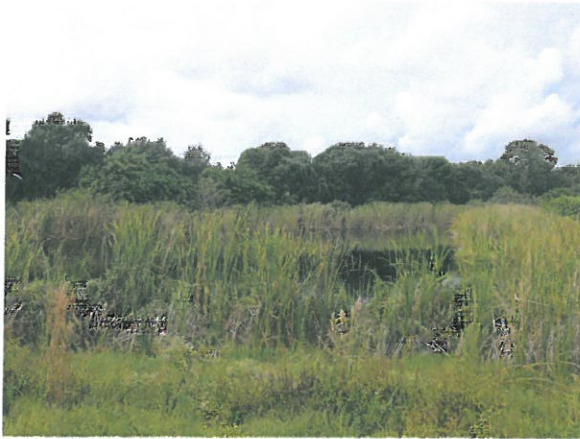
13. View Westward across lake/Vista # 6
